DETAILED MONITORING AND PRELIMINARY EVALUATION OF A LARGE FAÇADE-MOUNTED PV ARRAY

Anton Driesse
Steve Harrison
Solar Calorimetry Laboratory
Queen's University,
Kingston, Ontario, K7L 3N6, CANADA
e-mail: driessea@post.queensu.ca; harrison@me.queensu.ca

ABSTRACT

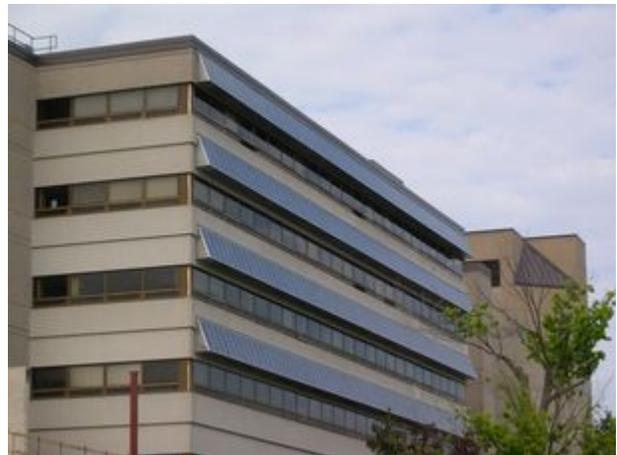
Fig. 1: Goodwin Hall, Queen's University at Kingston

The most efficient way to describe the array is by photograph. Fig. 1 illustrates the four rows of modules mounted as awnings above the windows of the top four floors of this seven-story building. The module slope and position relative to the windows are a compromise between electrical yield and aesthetics, and also between shading, daylight and view. The balance of system is installed in the adjacent building where the electrical room is more spacious. The specifications of the system are summarized in TABLE 1 below.

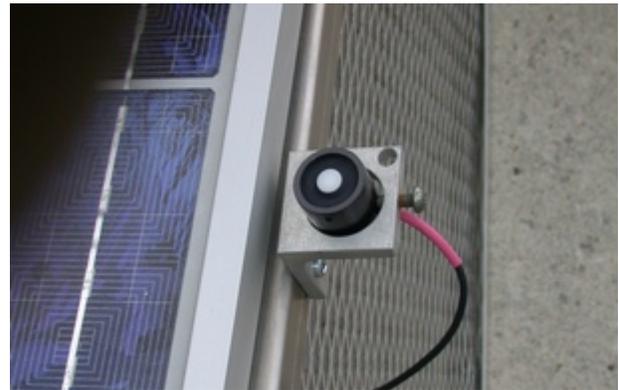
Each level of the array is equipped with a small pyranometer mounted at the extreme eastern edge to measure incident solar radiation in the plane of the array, as illustrated in Fig. 2. The four-fold redundancy invites comparison, and a plot of five-minute averages reveals some interesting discrepancies between winter and summer readings as shown in Fig. 3 and Fig. 4 respectively.

Fig. 2: Pyranometer mounting location.

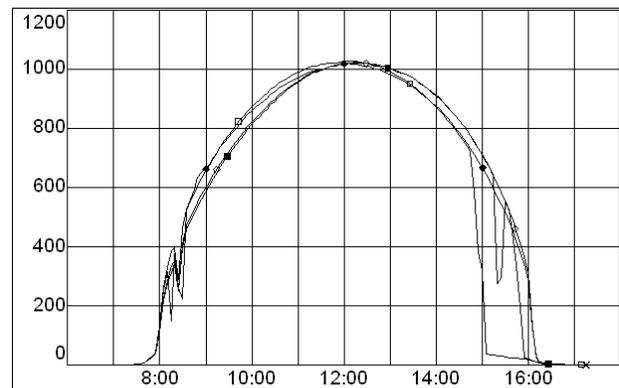
Fig. 3: Solar radiation [W/m^2] on December 13, 2003.

At solar noon in December sunlight arrives very nearly perpendicular to the plane of the array, and for this reason the highest readings are recorded at that time, as expected. The fact that the peaks for the different readings do not occur at the same time, is attributed to differences in mounting angle of the sensors – a difference that is easily seen, but not so easily corrected.

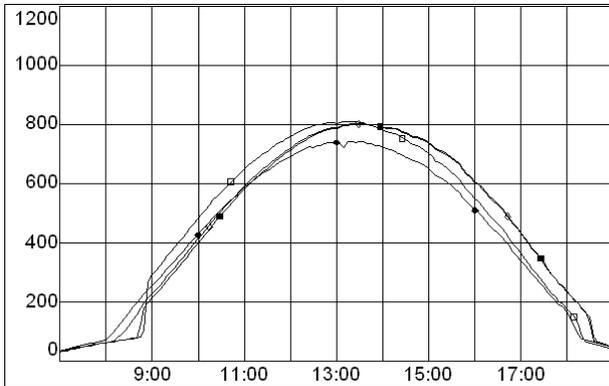
The most curious aspect of these graphs is that the summer graph shows the 7th floor sensor peaking at a significantly

lower value than the other three – 740 W/m² compared to 805 W/m². This was initially attributed to the sensor itself or the shunt resistor for lack of a better explanation, but when the discrepancy gradually disappeared through the fall and into the winter, another explanation was needed.

Fig. 4: Solar radiation [W/m²] on August 13, 2003.

The most plausible explanation at this time is that the lower three sensors pick up significant beam radiation reflected by the light concrete immediately above the arrays. The reflection would be partly diffuse, but the high summer sun would certainly produce stronger reflections in the direction of the pyranometer below than would the lower winter sun.

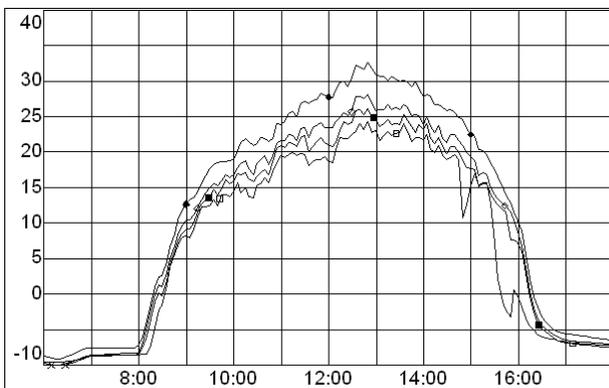
Fig. 5: Module temperatures [C] on each floor Dec. 13, 2003. The values are averages of three sensors mounted on back of a single module at each floor. The upper curve is for the 7th floor; the lower for the 4th floor.

During the design process concern about high temperatures was centred around the possible effects on the building interior and occupants. High temperatures are of course undesirable from a PV performance point of view as well. A portion of the heat rejected by the PV cells is carried away by air rising along the front and rear of the modules, and in this installation the rising hot air causes higher air and cell temperatures on the upper levels. As expected, the cumulative effect is greater at times when there is little wind.

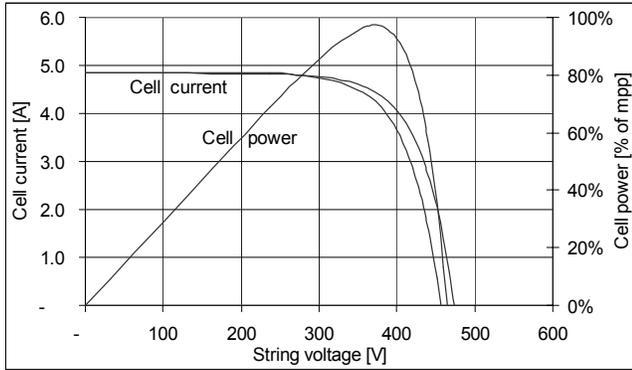
A simple 2-cell model can be used to show that cells (and similarly modules or strings) at different temperatures and should operate at an intermediate voltage when connected in parallel to capture the overall maximum power. At this voltage the hotter cells generate slightly less current than their cooler counterparts, and the combined maximum power level is slightly less than the sum of the individual maxima. This is illustrated in Fig. 6 where the voltage scale reflects the number of series cells in a string.

Fig. 6: Simple PV model showing the effect of a 10°C cell temperature difference with solar radiation at 1000 W/m^2 .

Around the time of the peak insolation and peak current at noon, the array is operating in the range 360-365 V. This is approximately where the simple PV model suggests it

should be, however the measured currents are about 5% lower than the model predicts. With the measured insolation level just over the magic 1000 W/m^2 there are at least other factors that could be contributing to this: wire resistance and cell mismatch.

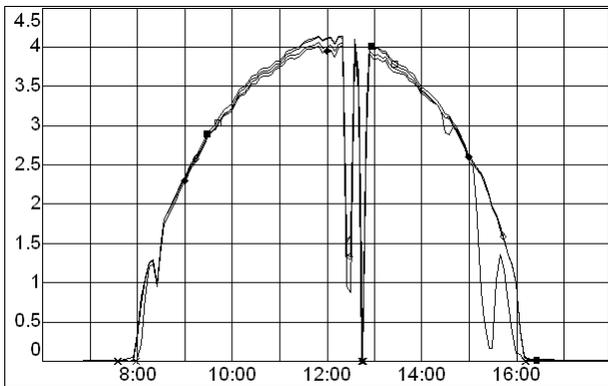
Fig. 7: Current [A] for the middle string on each of the 4 floors. The trace sequence from upper to lower curve is: 5^{th} , 4^{th} , 6^{th} , 7^{th} . (The sudden drops are discussed later.)

The discontinuities in the current readings of Fig. 7 are actually evidence of the inverter shutting down automatically. According to the inverter software alarm log, the voltage on one of the three phases exceeded the programmed threshold, which was set at 220.5 VAC. On this day, the inverter logs indicate the line-to-line voltage holding quite steady around 218 before the shutdown. Since the logs provide only one sample per minute, and 5 consecutive cycles above the threshold level are sufficient to trigger a shutdown, it appears that a brief surge caused the shutdown.

There are several aspects we note here. First, as soon as the inverter shut down, the grid voltage recorded by the inverter dropped by about 5 volts. In other words, the fact that the inverter was feeding 17 kW into the grid caused the voltage at its output terminals to increase by about 2.5%. It seems likely that this is in large part because the inverter must overcome the losses in the isolation transformer. The distribution panels and wiring on the grid side of the transformer have current ratings much higher than the PV output and should not incur voltage drops of this magnitude. If the transformer is indeed responsible for most of this voltage change, then voltage further out on the grid did not really exceed the specified threshold.

Second, with the arrival of the cold, bright days of January, the inverter shut down more and more often, setting a record of 22 times in succession between 10am and 2 pm on January 10th. Each time after shutting down, the inverter sensed that the grid voltage was back to normal (which it was) and started up again. But immediately after starting it would sense a high voltage and shut down again. There appears to be no dead band or hysteresis associated with this threshold to prevent cycling, and only the 6-minute start-up delay prevented it from cycling more frequently.

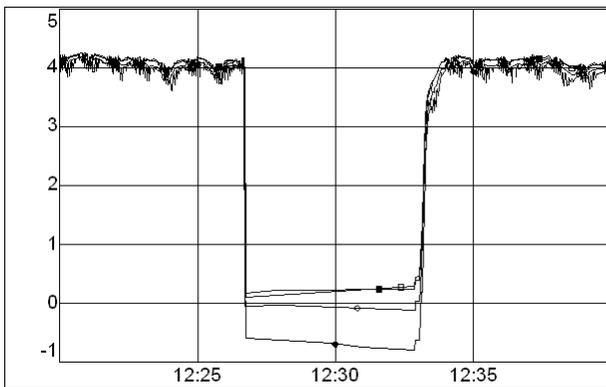
Fig. 8: Currents of the middle strings of each floor during inverter shutdown. The large negative current is on the 7th floor where the cells are hottest.

The frequent shutdowns were disappointing from a performance point of view, but provided some exceptional data as well. As discussed in Section 3.4.1, temperature differences between floors produced small differences in operating point. When the inverter shuts down the total array current drops to zero, and the voltage rises toward V_{oc} . V_{oc} is different for each cell of course, but near V_{oc} the slope of the IV curve is very steep. Thus when the array stabilizes at one voltage, the currents show much more variation as is seen in Fig. 8 below.

The time range of the previous figure is sufficiently short that a pattern is discernable in the current variations before and after shutdown. The close-up below confirms this in greater detail. The perturbations in the four currents appear to be somewhat synchronized, and the total current (not shown) shows a similar pattern. Determining the exact

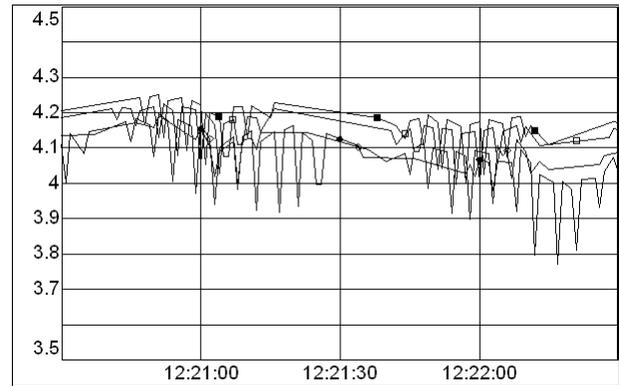
nature of these variations will require further investigation. It seems likely that there is a link with the MPPT (maximum power point tracking) algorithm, which typically fluctuates around the maximum point, but the nature of this link is unclear. Since the sampling rate is around 1 Hz, and there is no filter to prevent aliasing of signals below 60Hz, the actual signal could look quite different.

Fig. 9: Close-up of four string currents showing periodic perturbations.
